Crude Oil Leakage -2" DCP (De-congenial Pipeline) on 08th night of October 2013 in a Oil & Gas Unit at the outskirts of Mumbai westcoast.

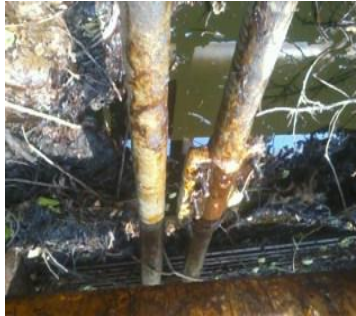
On 8th October'13 leakages observed in 3 nos. pipe lines of 2" size.

Damaged Pipes

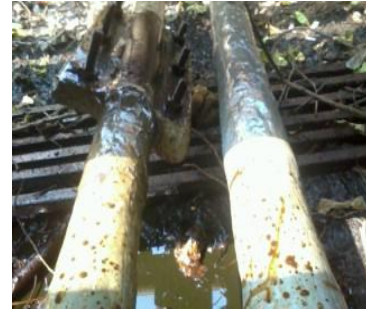
Damaged Pipes

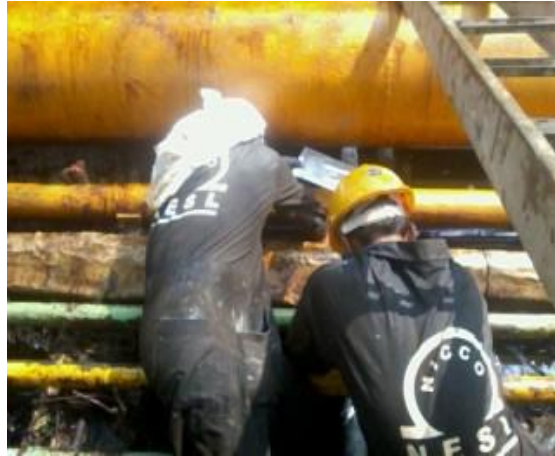
Repairing Job Under Process

We received an emergency call on 9th morning to mobilize manpower for the said job. We offer Belzona Super System (with Belzona 1831 and Belzona 9371).

This Super Wrap System strengthened pipe line and can be considered as permanent repair.

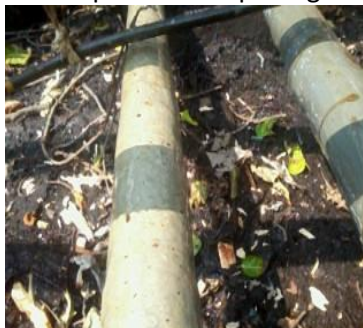
Pipes After Repairing

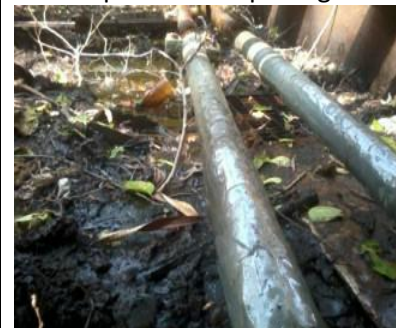
Pipes After Repairing
