Case History

Belzona Saves Huge Cost Of Replacement & Production Loss In Paper Industry

Paper Manufacturing Unit, Balasore, Orissa, India

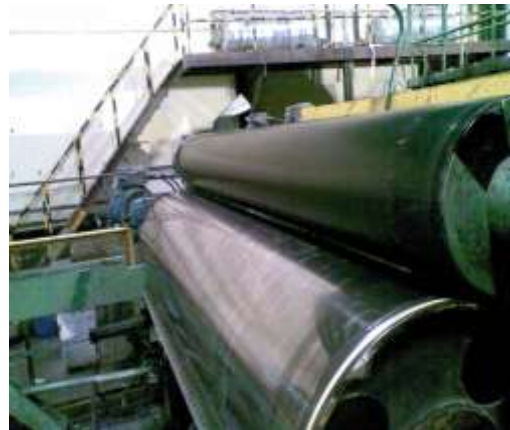
Localised mechanical damage on Pope Drum was stopped the paper production as it was producing non – standard paper.

1. Pope Drum & Felt Roll
2. Closer View of Damaged Pope Drum
3. Finished application

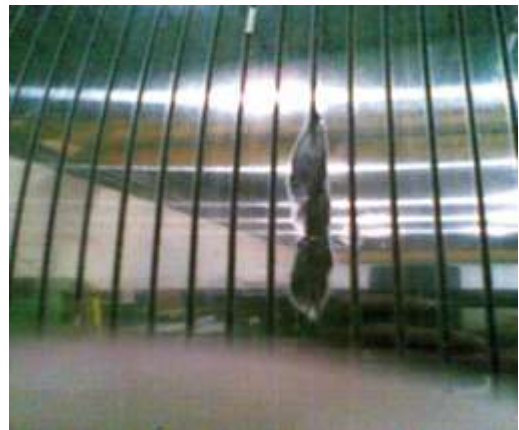
Started producing non – standard paper and there was a chance to further damage to fiberglass coated Felt Roll.

Rebuild the damage portion with Belzona® 1111 after surface preparation and top coated with Belzona® 1321. Application was carried out in accordance with Belzona Know-How System Leaflet SHM 12. The machine was put in operation within 20 hours.
