Case History

WORLDS LARGEST PHOSPHORIC ACID PLANT USES COST EFFECTIVE BELZONA SOLUTION

Phosphoric acid plant, Orissa, India

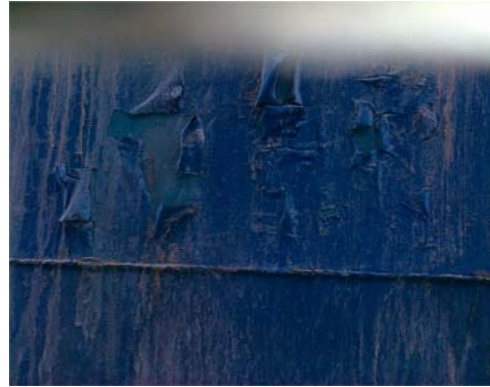
Storage Tank - Capacity - 2650 T / Day was suffering huge chemical and environmental corrosion due to fumes of Phosphoric and Sulphuric acid and coastal environment.

Standard Epoxy paints were peeling off within 6-8 months and outside of storage tanks get heavily corroded , mainly on the bottom portion at a height of 2 metres from the foundations.

1. Deterioration of existing coating on Phosphoric acid storage tank clearly evident
2. Surface preparation done by grit blasting
3. Application of Belzona® 4311
4. Finished application
