Case History

Belzona Refurbish Propeller of a Dredging Ship

Kolkata Port Trust, Kolkata, India

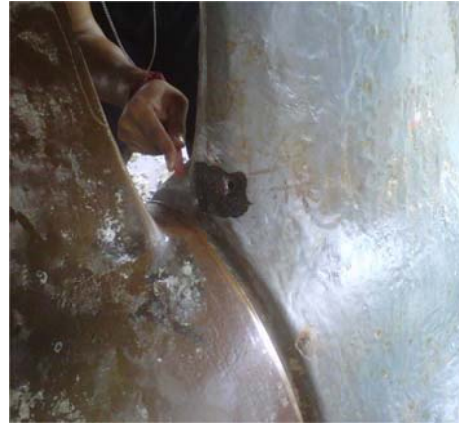
Propeller was badly corroded and hole was formed due to severe corrosion.

1. Damaged propeller
- 2 & 3. Finished application

Rebuilding was done by Belzona® 1831 along with Belzona® 9341 after manual surface preparation .
