# LEAK SEALING KNOW HOW *IN ACTION*

## ON – LINE LEAK ARRESTING OF STEAM LINE

THERMAX LIMITED, MAHARASHTRA, INDIA

Main inlet F W Flange Joint Line

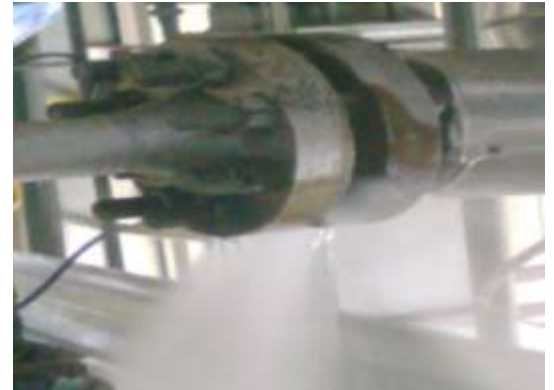
Gasket failure, plant could not take shut down due to heavy production loss.

1. Leakage
2. Clamp fitted and injection in progress
3. Leakage finally arrested
