BELZONA RECLAIMS VESSEL MONKEY ISLAND DECK

VanOord India Pvt Ltd, Mumbai, India

Deck roof above vessel control room

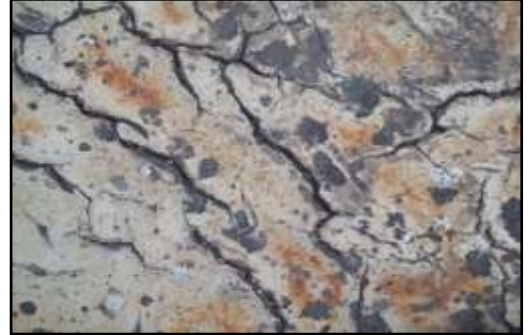
Rain water leakage through corroded and holed pitted areas resulting in short circuiting control room computers and equipments

1. Damaged deck roof area.
2. Corroded pitted areas filled up.
3. Belzona MR-7 coating in progress.
4. Completed application.
