SOLARTECH REPAIRS TO HOLED SUB SEA CRUDE PIPELINE

OIL & NATURAL GAS CORPN LTD, MUMBAI, INDIA

5 MTR CRUDE OIL PIPELINE, TROMBAY, MUMBAI

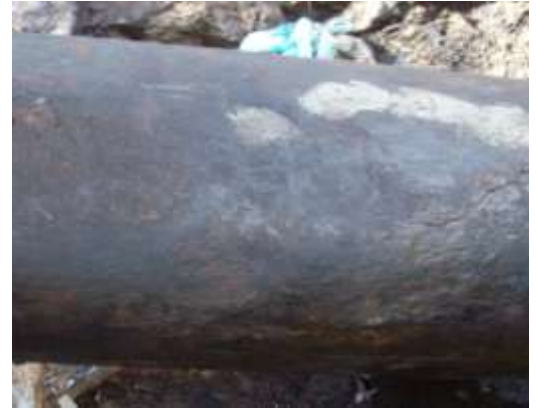
THIS 30 YEARS OLD LINE WHICH WAS HAVING 03 PUNCTURED HOLES (CLAMPED) WAS LYING DORMANT WITH CRUDE OIL. TO REMOVE THIS OIL THEY HAD TO PRESSURIZE THE LINE WITH WATER @ 20 KGS FROM BUTCHER ISLAND TOWARDS TROMBAY, HENCE THE REPAIRS REQUIRED FROM NESL.

1. DAMAGED AND THINNED DOWN PIPELINE
2. SOLARSEAL RESIN APPLIED
3. SOLARTECH VE 55 COMPLETED PIPELINE

HOLES WRE PLUGGED USING BELZONA 1831, SOLARSEAL RESIN APPLIED TO THE REPAIR LENGTH OF 5 MTRS. 2 WRAP SOLARTECH VE 55 SHEETS APPLIED
